Manhole Inspection Summary

Manhole # S53K__067MH

Location Address: **rear off 611 S Clinton st**

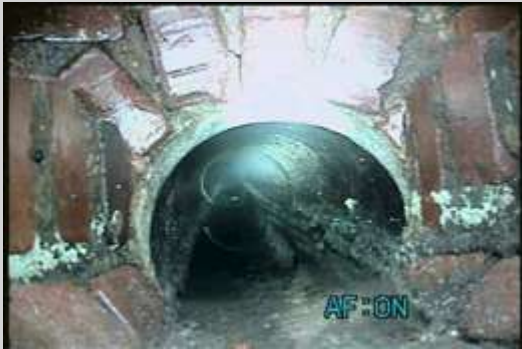
12 O'Clock Outflow

8 in. Circular Gravity Sewer
Pipe Out @ 12 O'Clock

Pipe Material: **Clay** ☐ Pipe Lined

Invert Depth: **8.50** (ft.) Flow Characteristics: **Slow**

Infiltration: **None** Pipe Seal Cond: **Unknown**

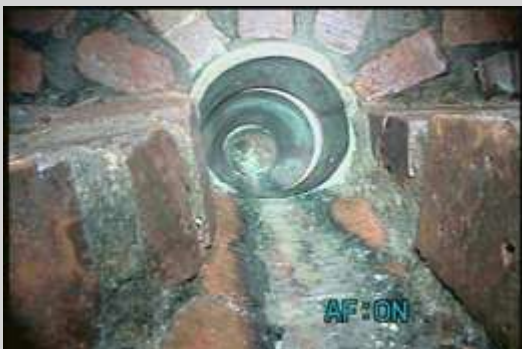
3 O'Clock Inflow

8 in. Circular Gravity Sewer
Pipe In @ 3 O'Clock

Pipe Material: **Clay** ☐ Pipe Lined

Invert Depth: **8.16** (ft.) Flow Characteristics: **None**

Infiltration: **None** Pipe Seal Cond: **Unknown**

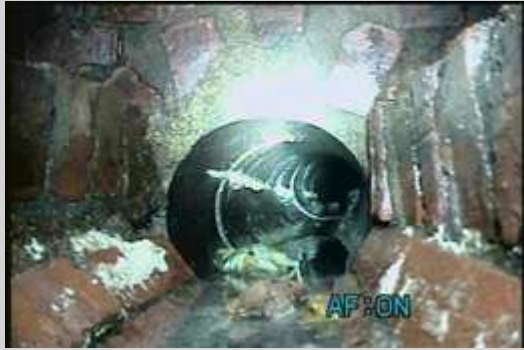
6 O'Clock Inflow

Pipe In @ 6 O'Clock

Pipe Material: **Clay** ☐ Pipe Lined

Invert Depth: **8.25** (ft.) Flow Characteristics: **Slow**

Infiltration: **None** Pipe Seal Cond: **Unknown**

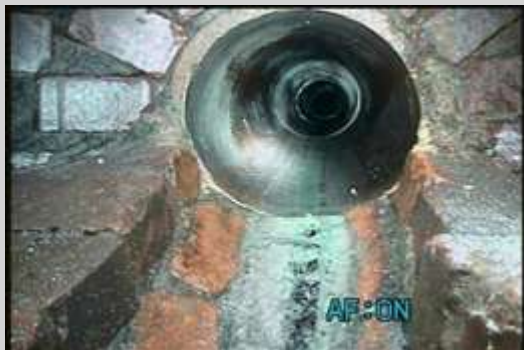
9 O'Clock Inflow

Pipe In @ 9 O'Clock

Pipe Material: **Clay** ☐ Pipe Lined

Infiltration: **None** Pipe Seal Cond: **Unknown**
